**EXPANDED SITE INSPECTION REPORT
WILCOX REFINERY
CREEK COUNTY, OKLAHOMA
EPA CERCLIS ID # OK0001010917**

**STATE OF OKLAHOMA
DEPARTMENT OF ENVIRONMENTAL QUALITY
LAND PROTECTION DIVISION
SITE ASSESSMENT UNIT**

Date: September 30th, 2011

Site: Wilcox Refinery, Creek County

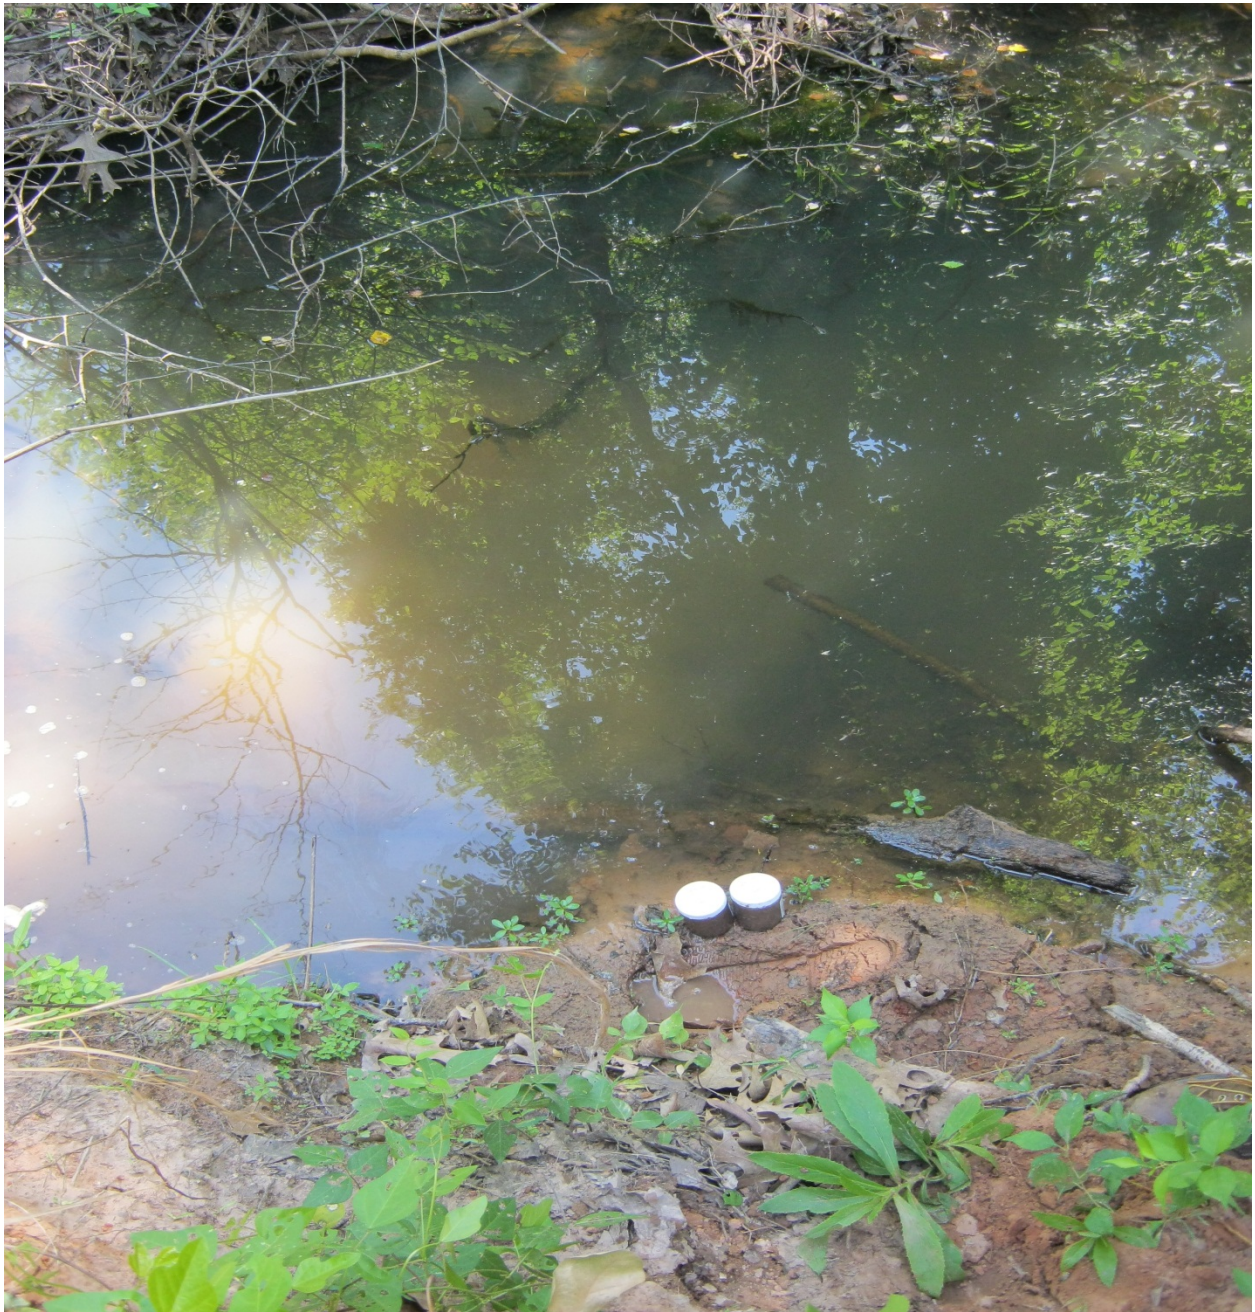
Photo #14

Photographer: Todd Downham Date: 6/29/2011 Direction: Down Comments: Sediment sample SED-10 location, East tributary, North of Site boundary.

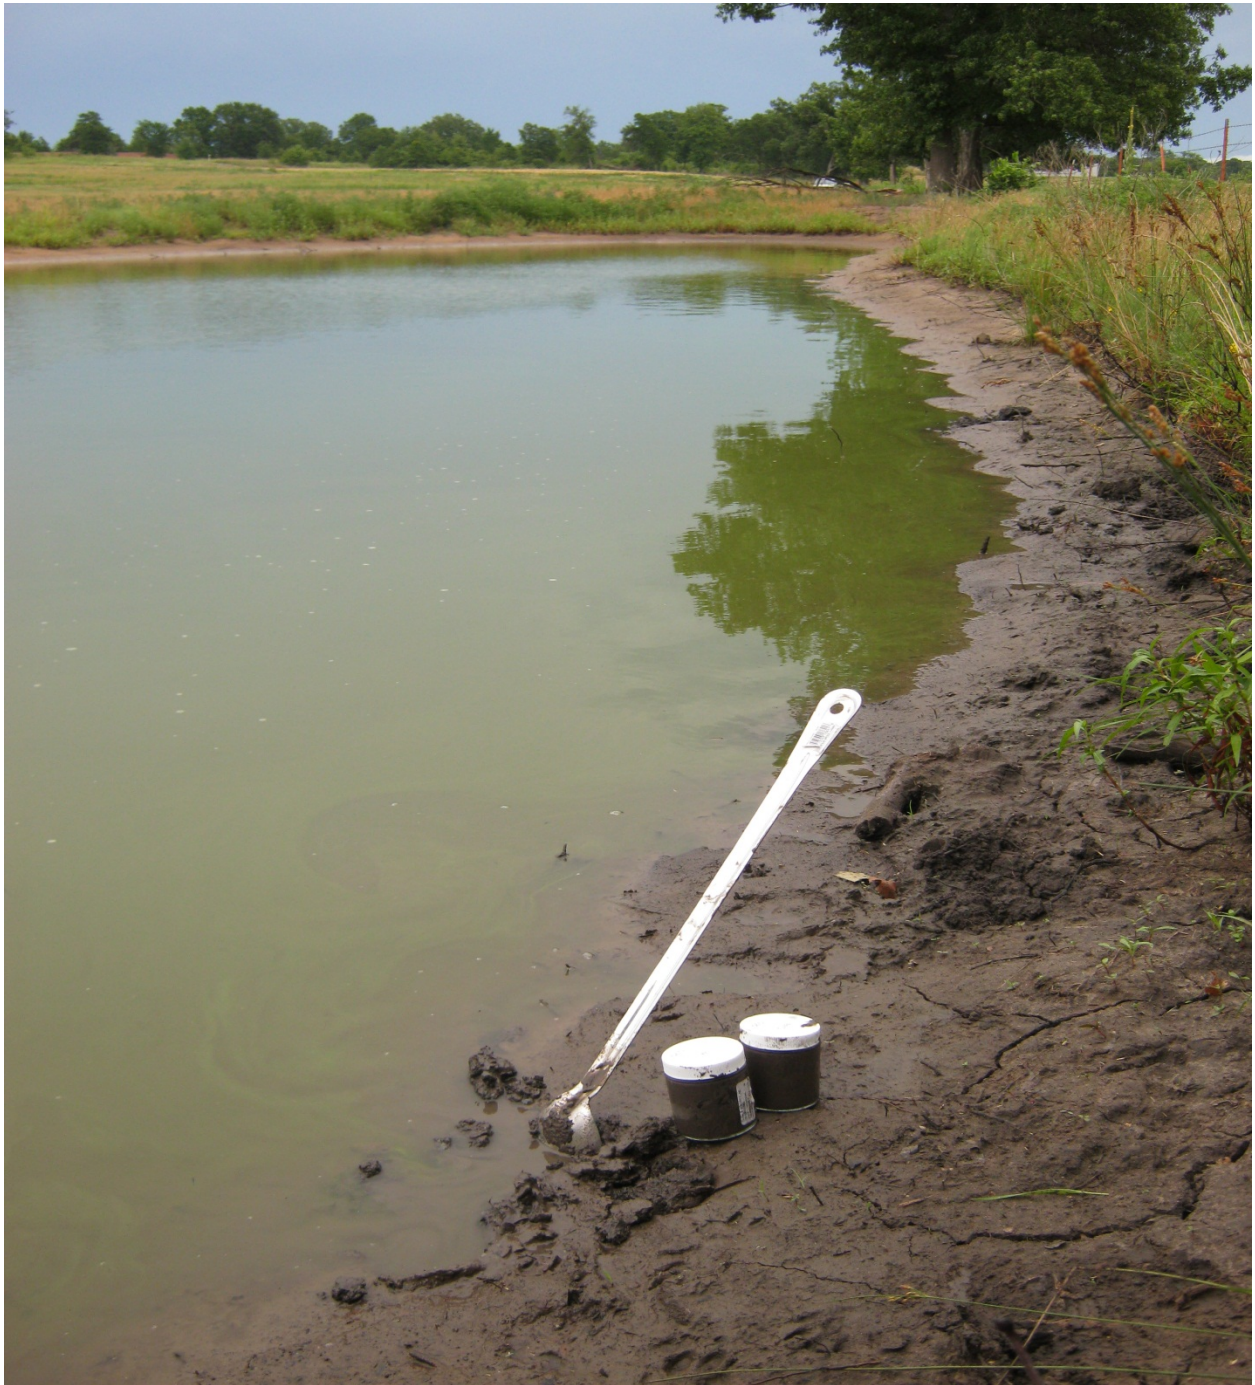
Photo #15

Photographer: Todd Downham Date: 6/28/2011 Direction: East Comments: Sediment sample SED-11 location, Pond near southern boundary.

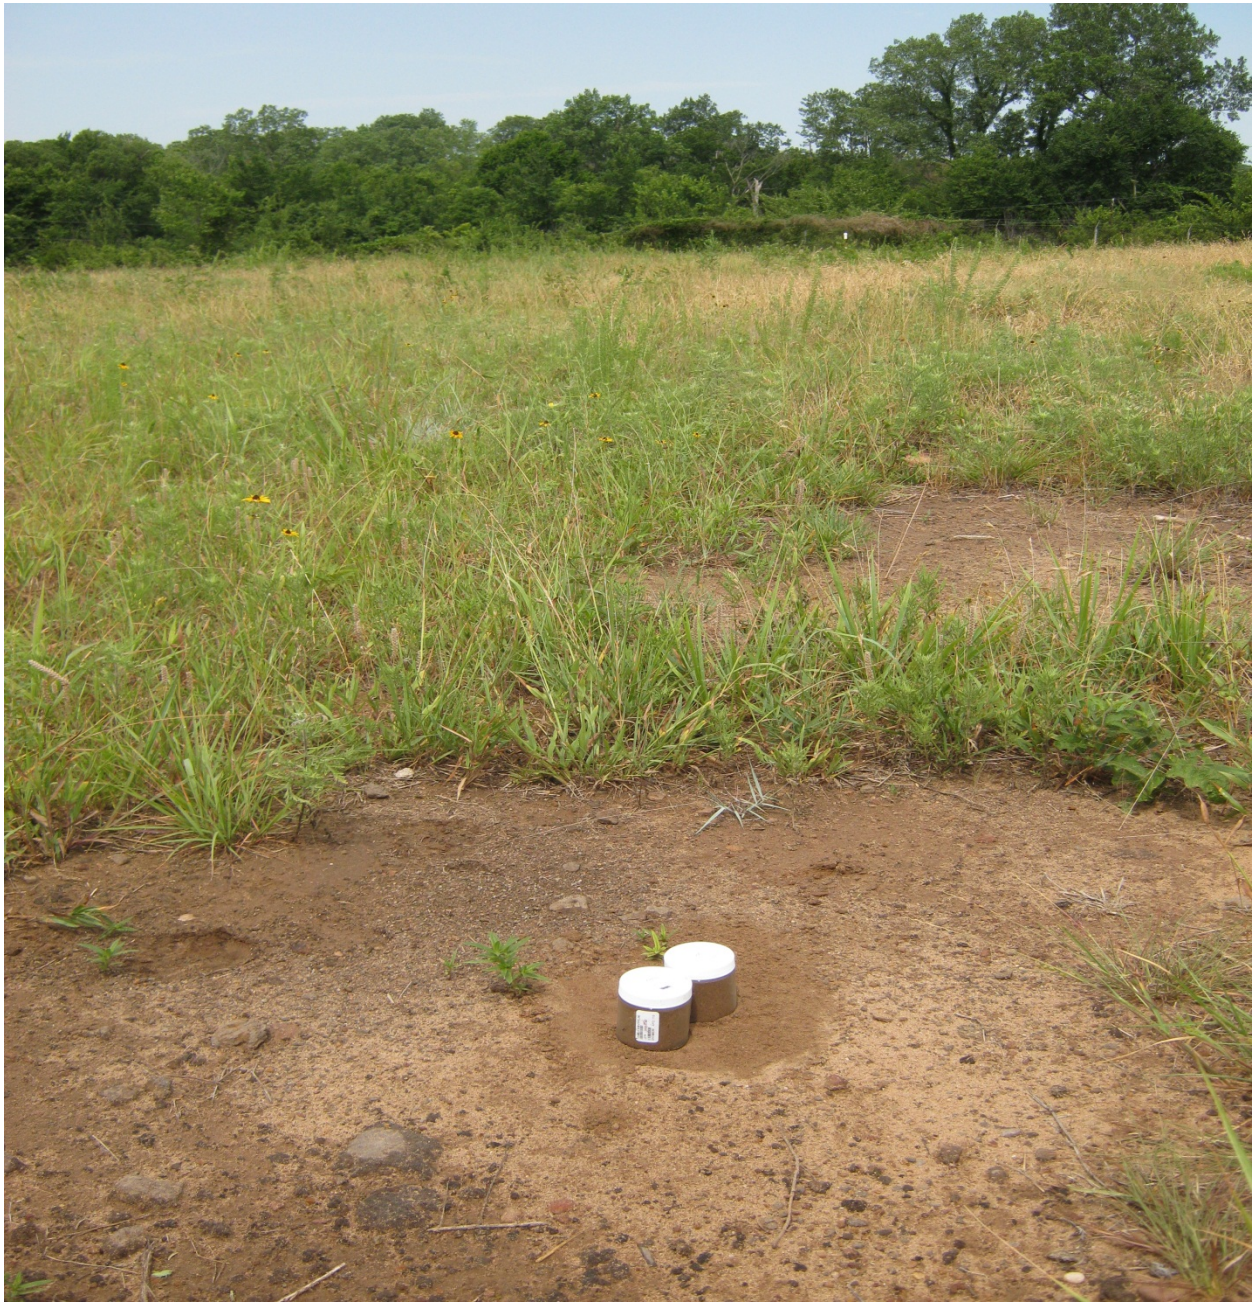
Photo #16

Photographer: Todd Downham Date: 6/28/2011 Direction: Northwest Comments: Waste sample W-1 location, former tank location.

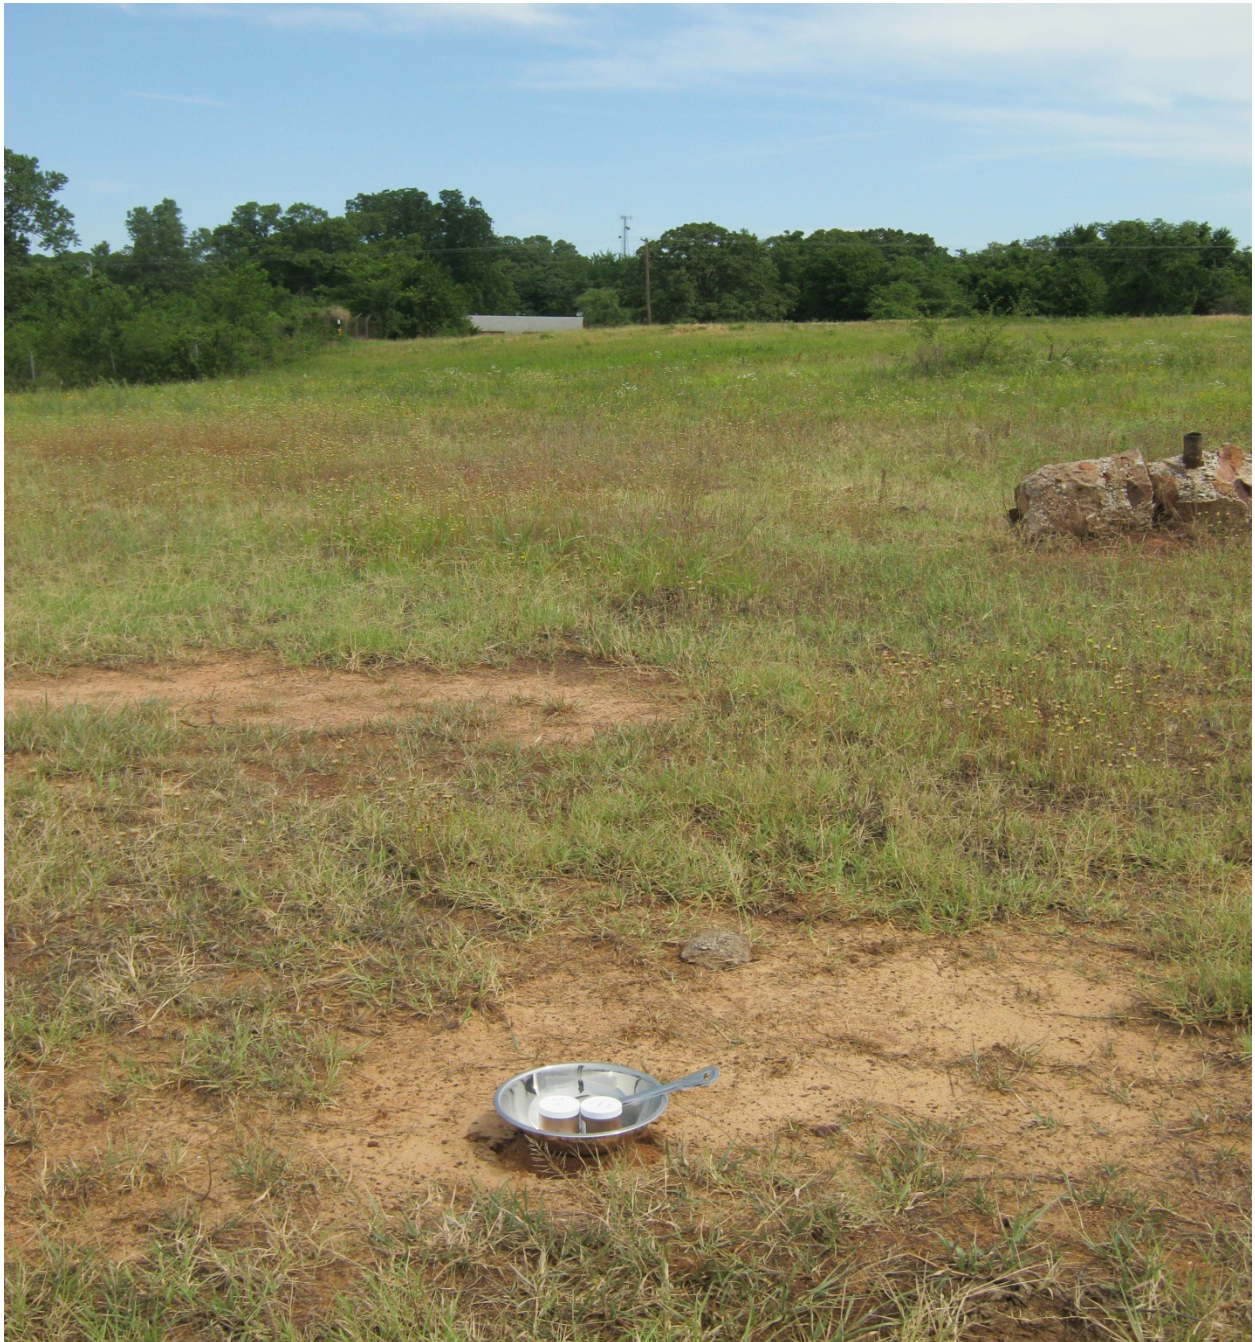
Photo #17

Photographer: Todd Downham Date: 6/28/2011 Direction: North Comments: Waste sample W-2 location, former tank location.

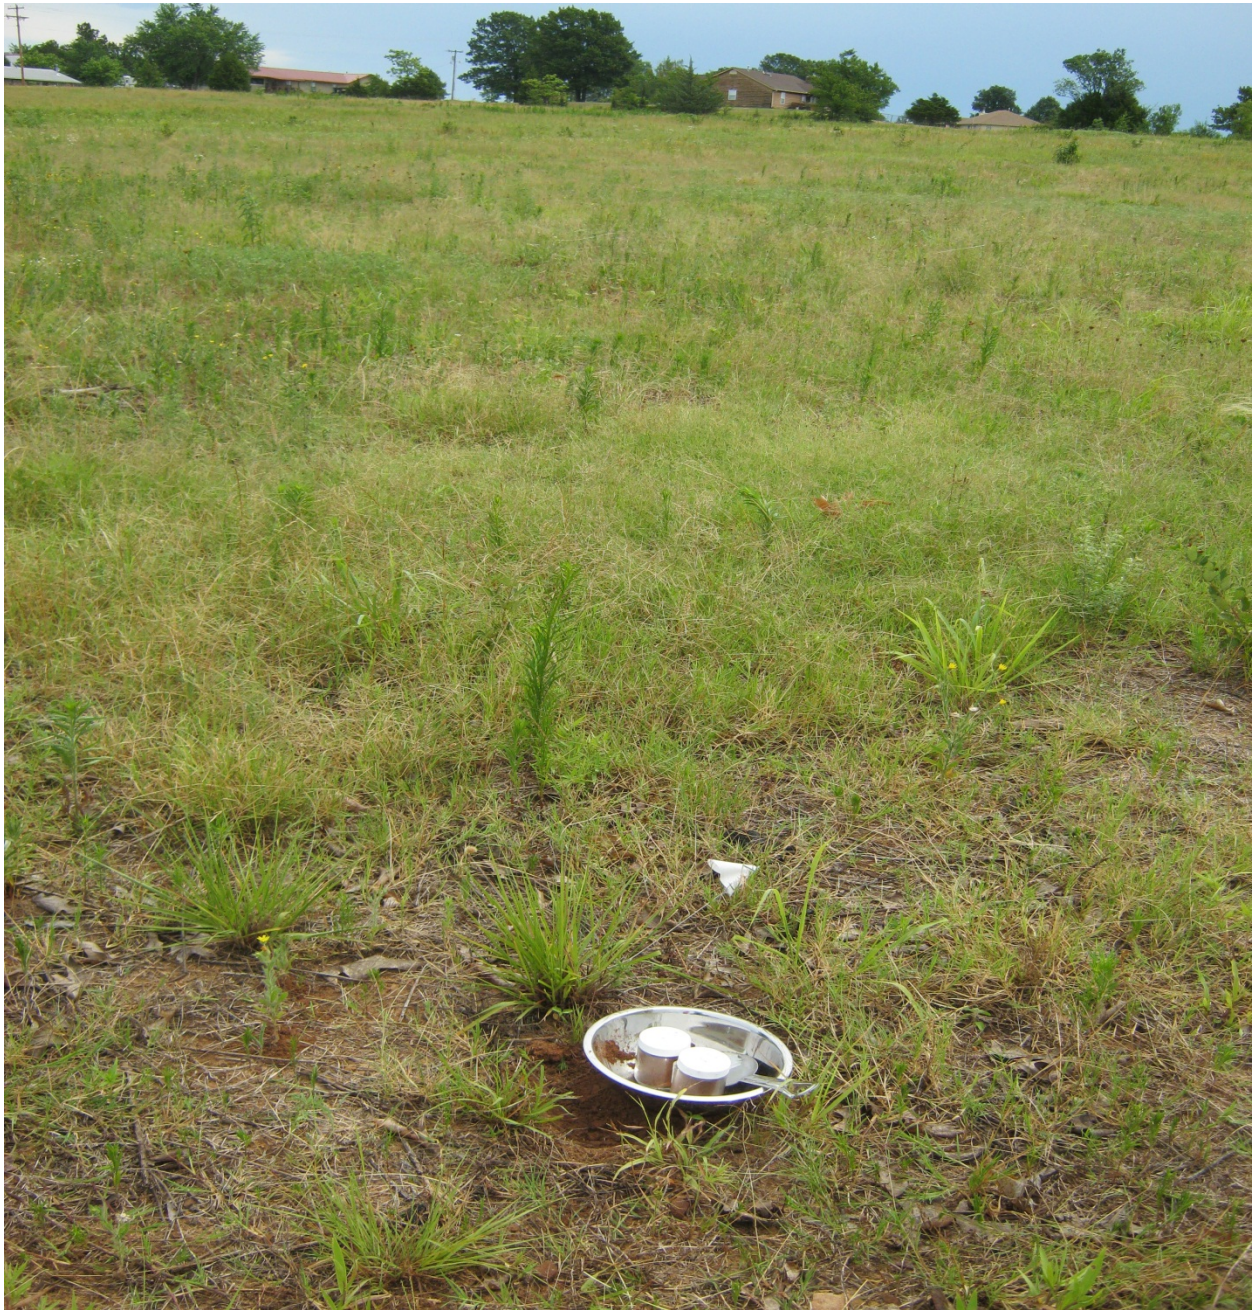
Photo #18

Photographer: Todd Downham Date: 6/28/2011 Direction: Northeast Comments: Waste sample W-3 location, former tank location.

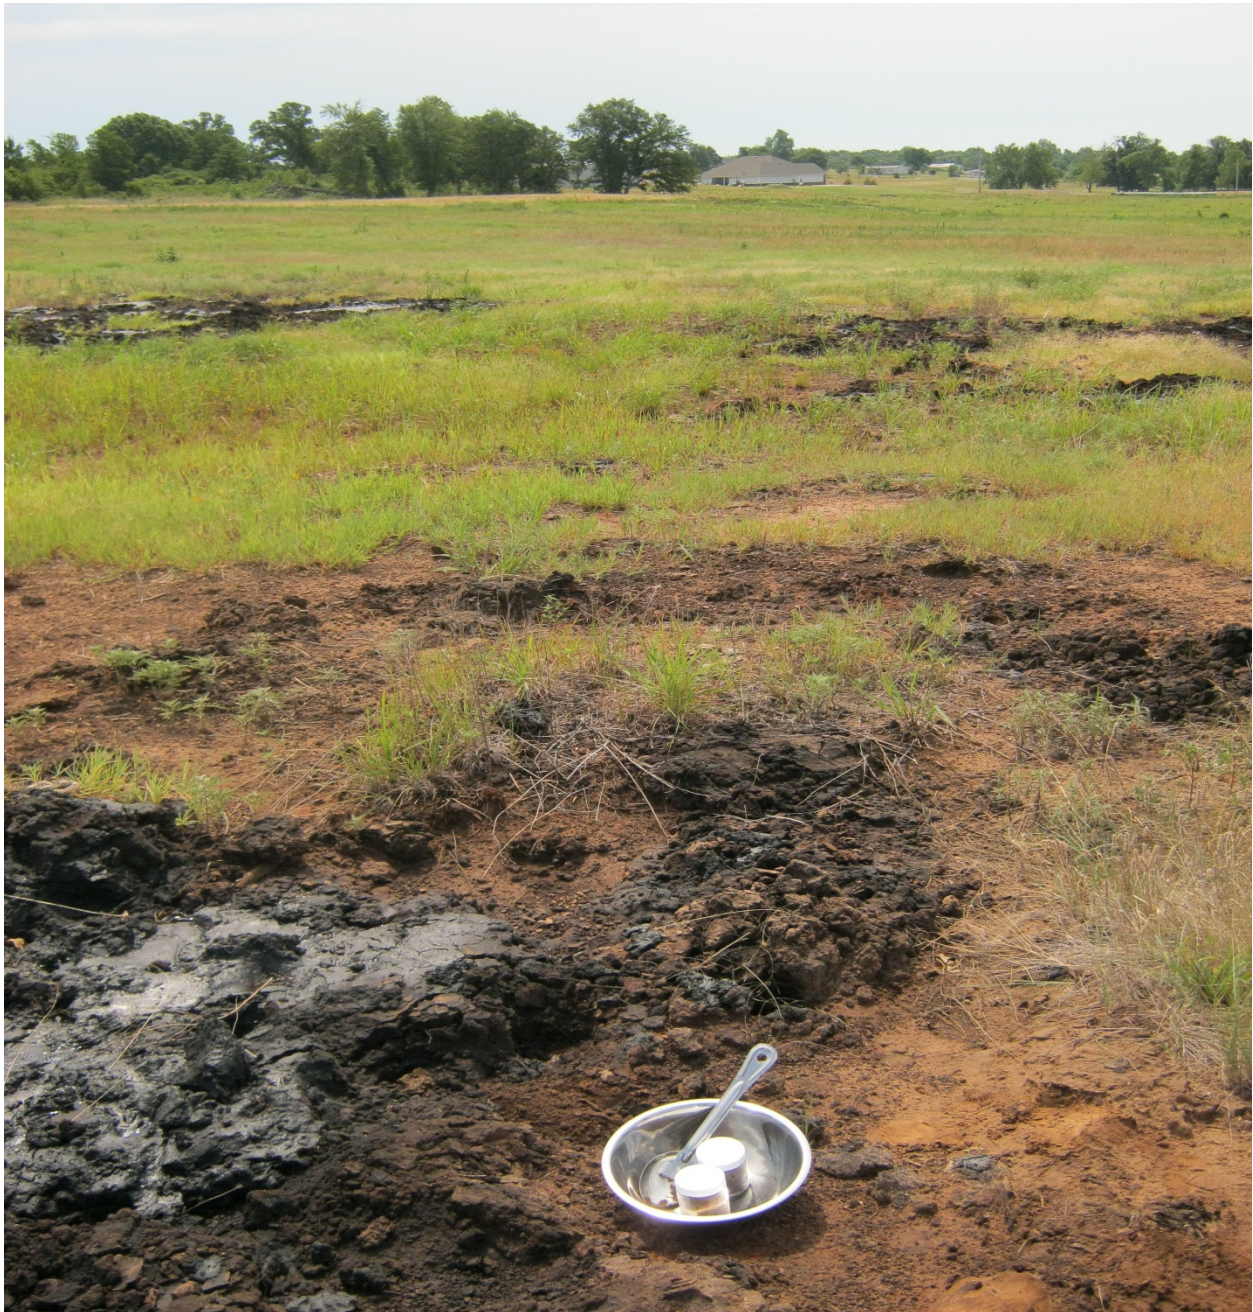
Photo #19

Photographer: Todd Downham Date: 6/28/2011 Direction: Southeast Comments: Waste sample W-4 location, former tank location, large area of waste.

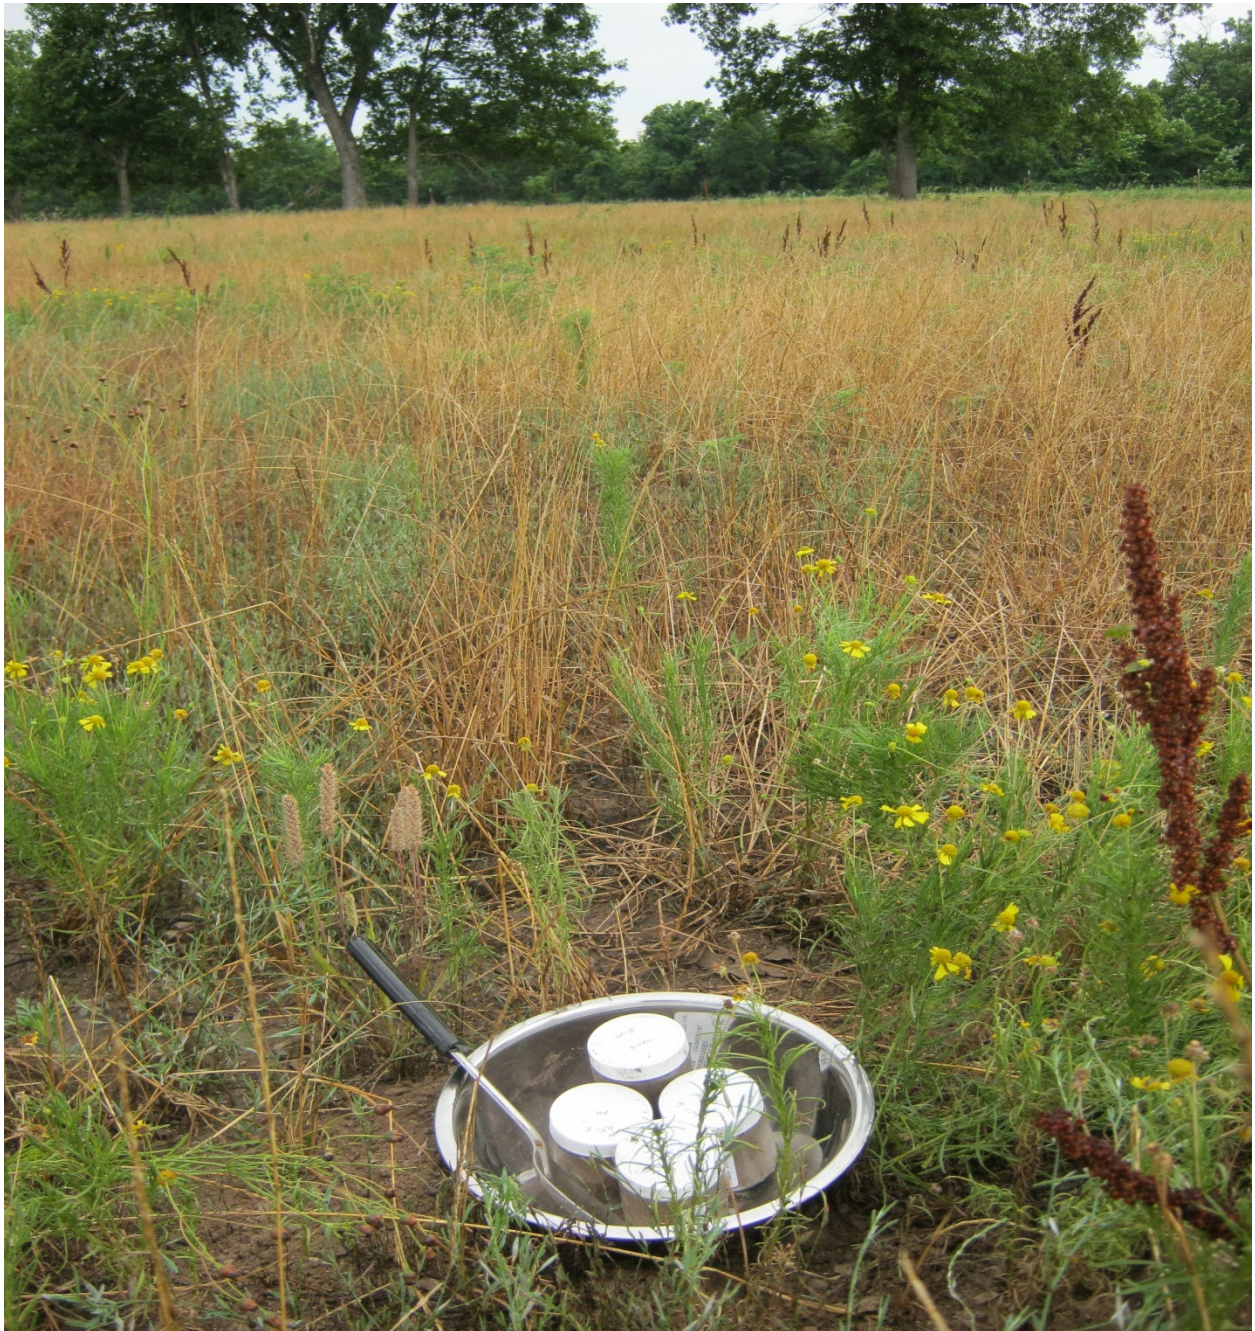
Photo #20

Photographer: Todd Downham Date: 6/28/2011 Direction: South Comments: Waste sample W-5(6) location.

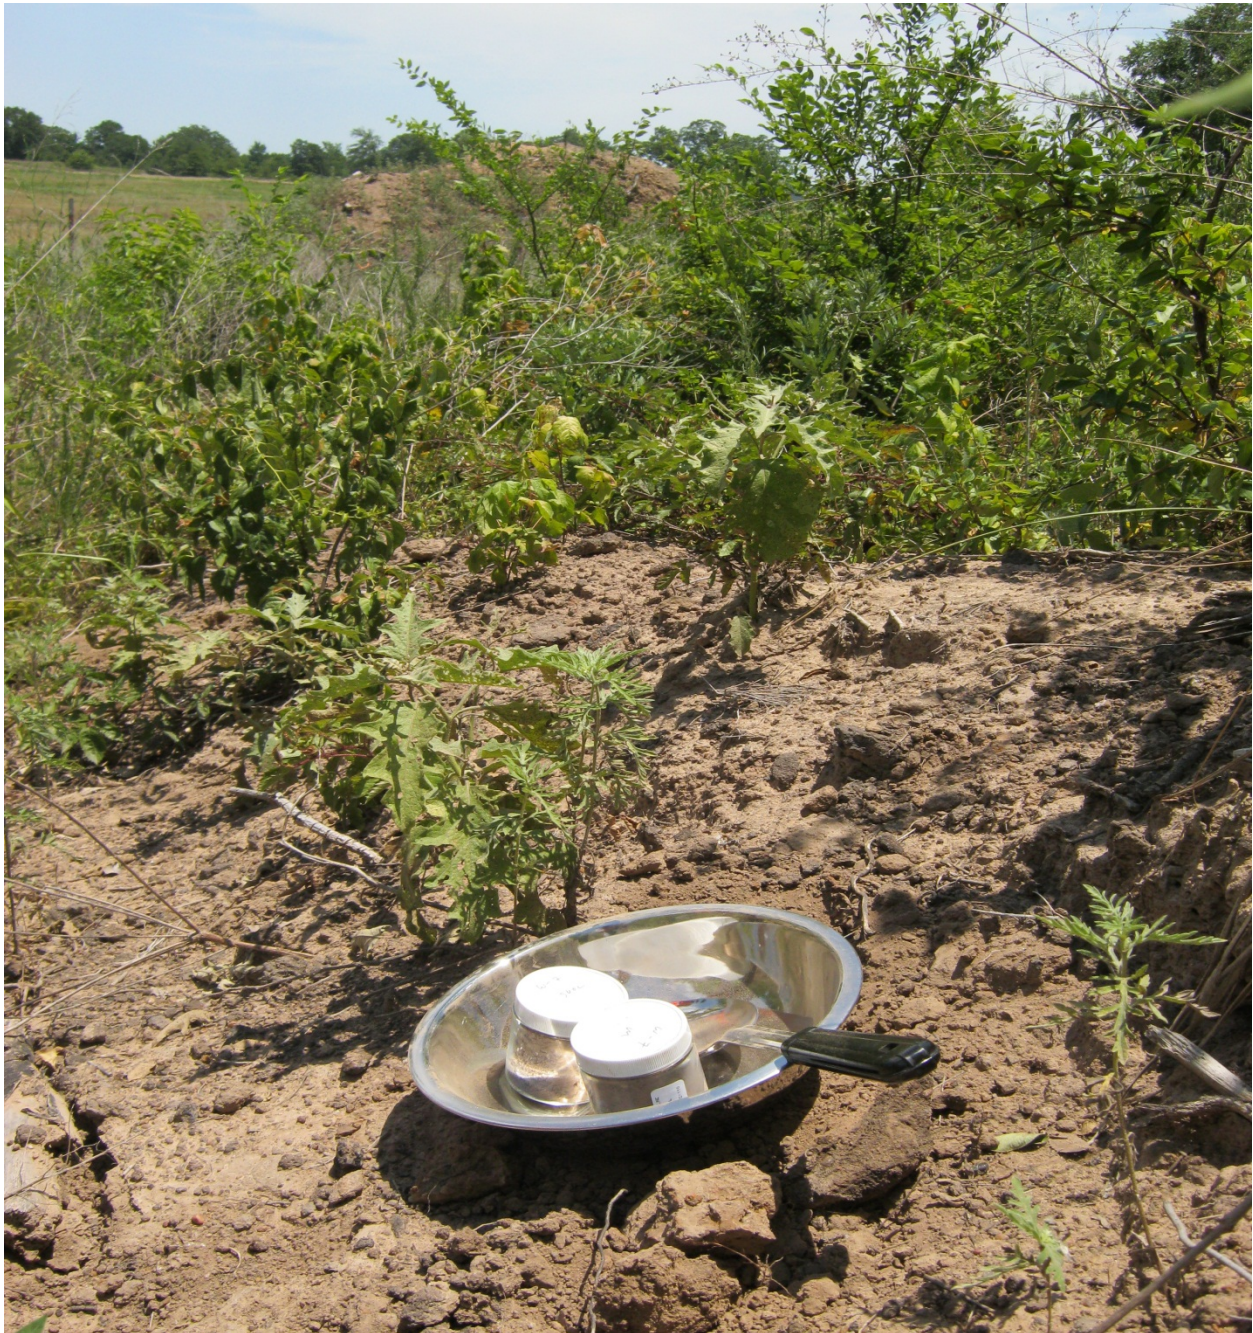
Photo #21

Photographer: Todd Downham Date: 6/29/2011 Direction: East Comments: Waste sample W-7 location, former tank location, large amounts of waste.

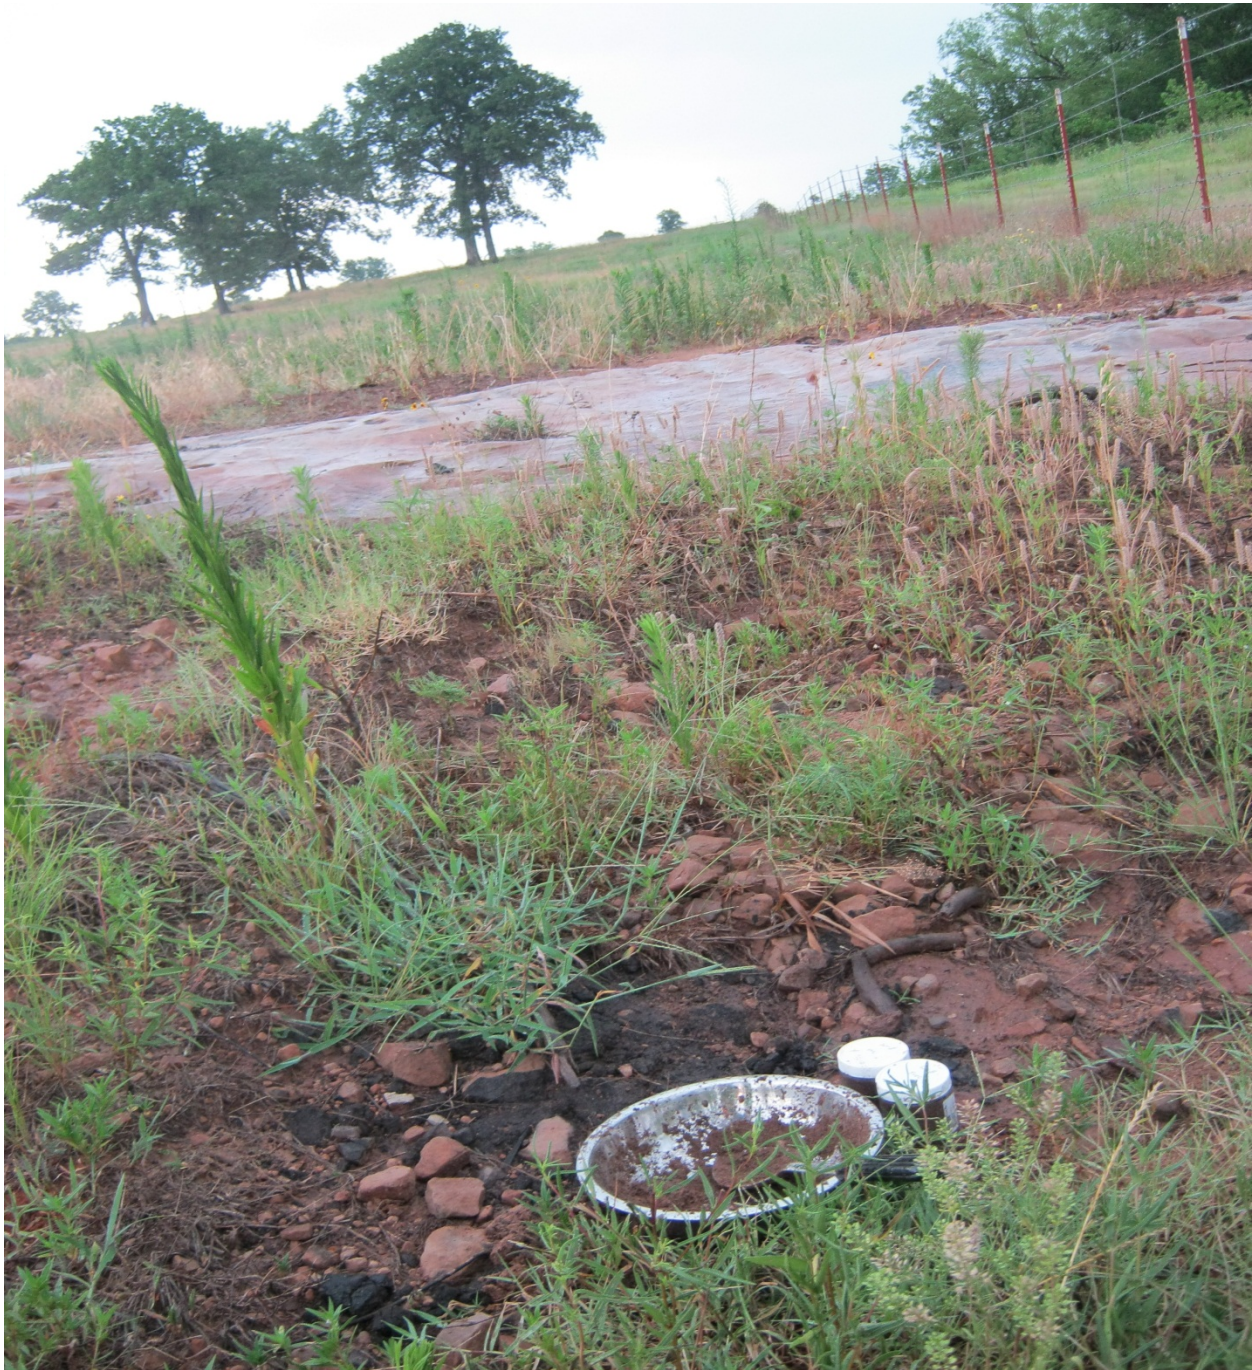
Photo #22

Photographer: Todd Downham Date: 6/28/2011 Direction: North Comments: Waste sample W-8 location, visible waste.

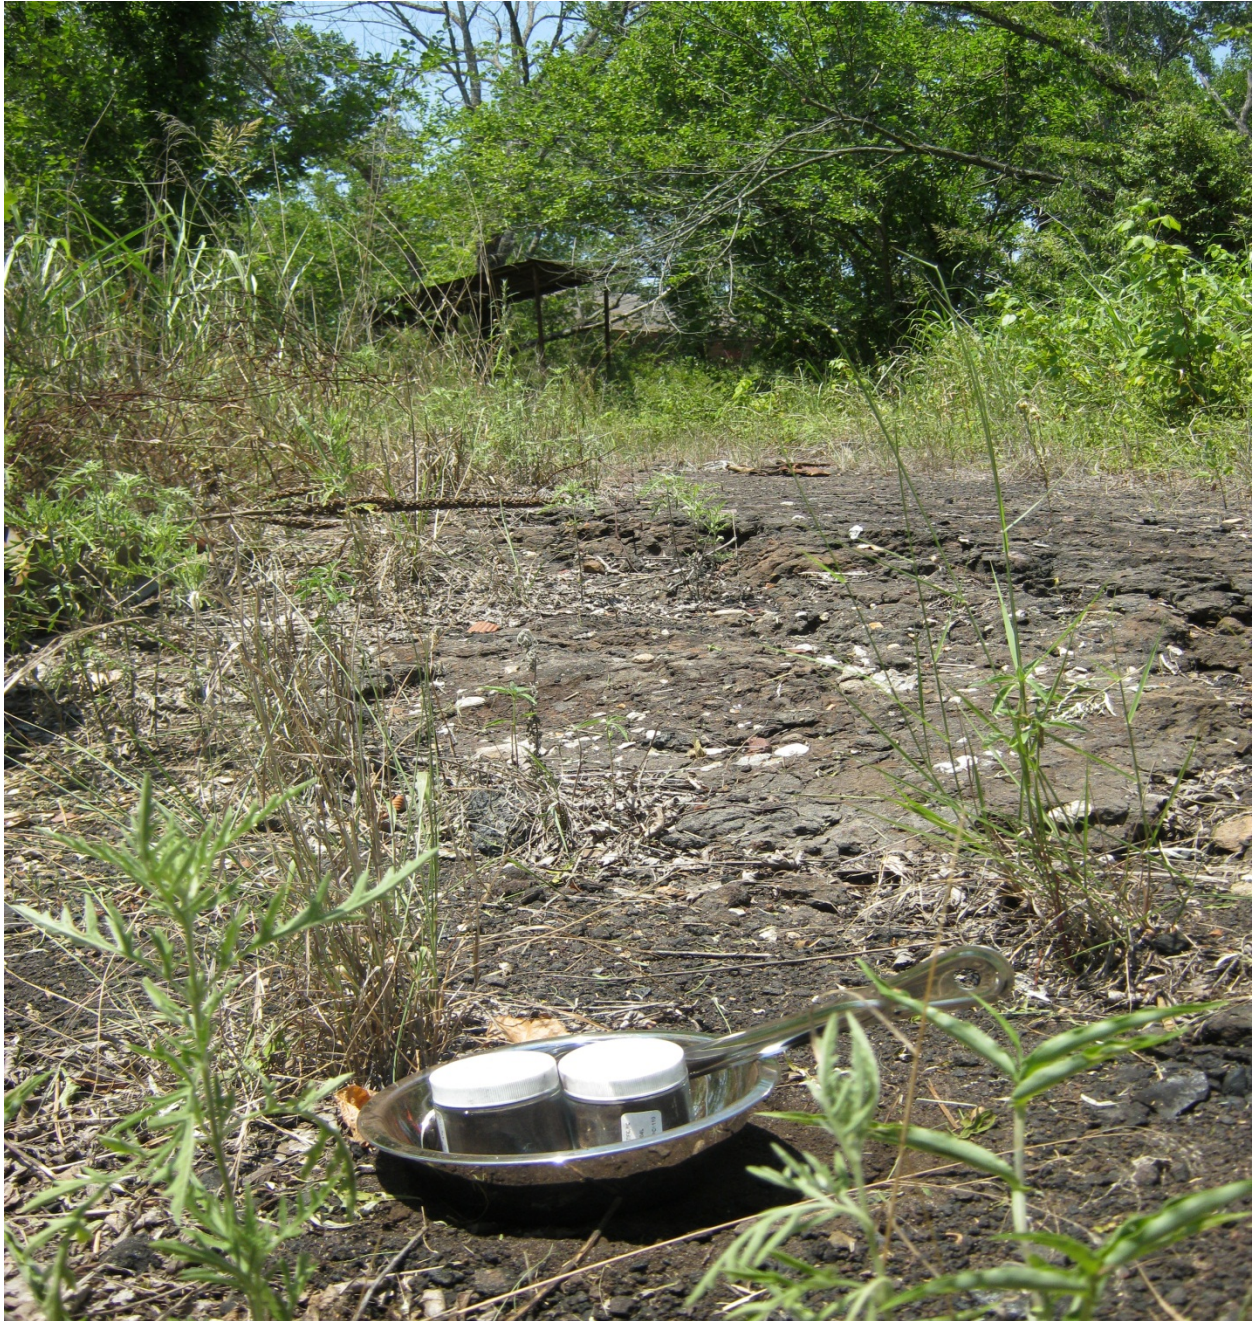
Photo #23

Photographer: Todd Downham Date: 6/29/2011 Direction: Northwest Comments: Waste sample W-9 location, east of west tributary.
